Spy Pond Edge Protection and Erosion Control Project

Site Characterization Report

Town of Arlington

December 2016

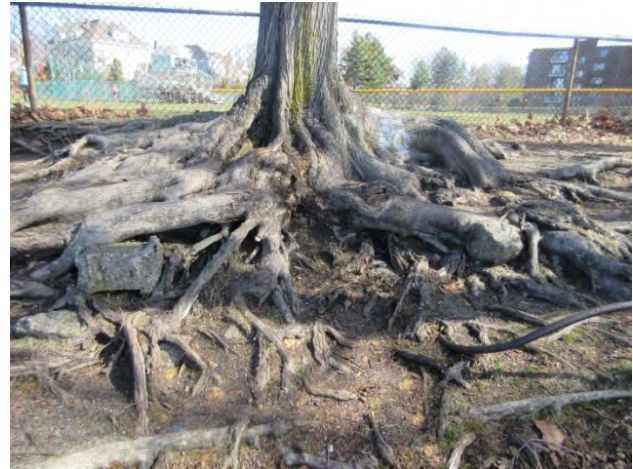
Numerous old growth trees line the shoreline with extensive root structures providing partial stabilization to portions of the slope and the vertical bank in the vicinity of the water line. In many cases, however, the roots are being undermined by wave action that has eroded soil for depths up to two feet into the slope beneath the roots. Considerable erosion is occurring along vertical banks that are not contained by roots.

Photograph 1: Tree with Exposed Roots

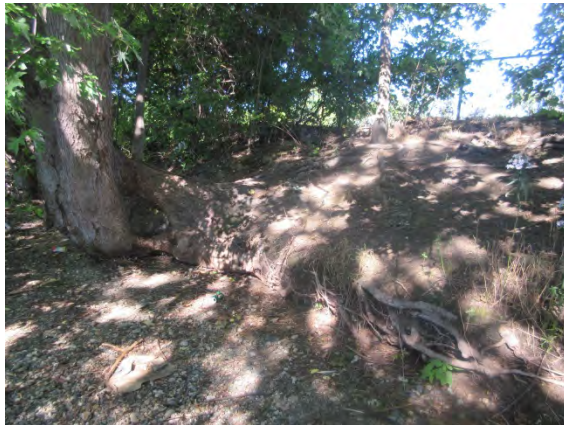
Photograph 2: Erosion with Visible Undercutting

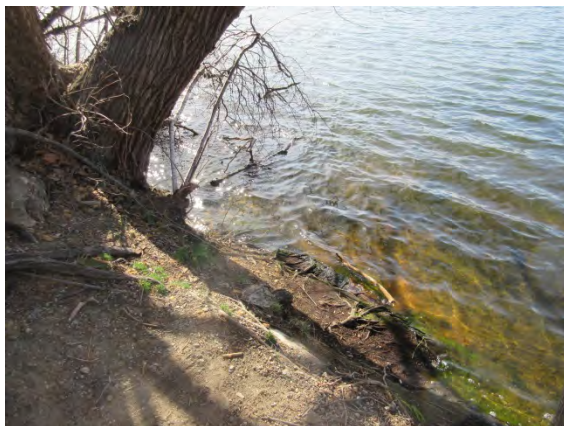
Photograph 3: Erosion and Lack of Vegetation

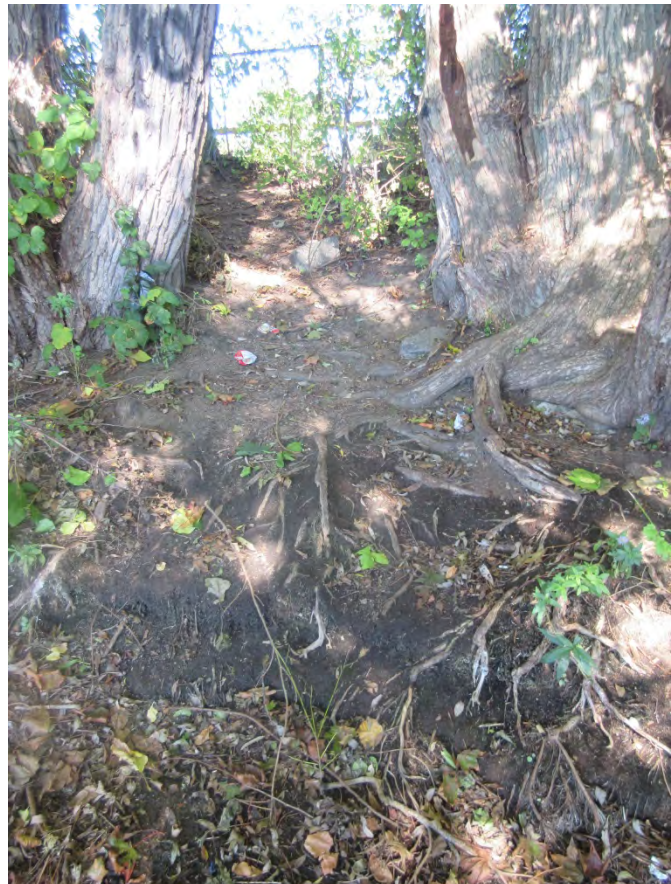
Photograph 4: Unstable Bank with Exposed Roots and Undercutting

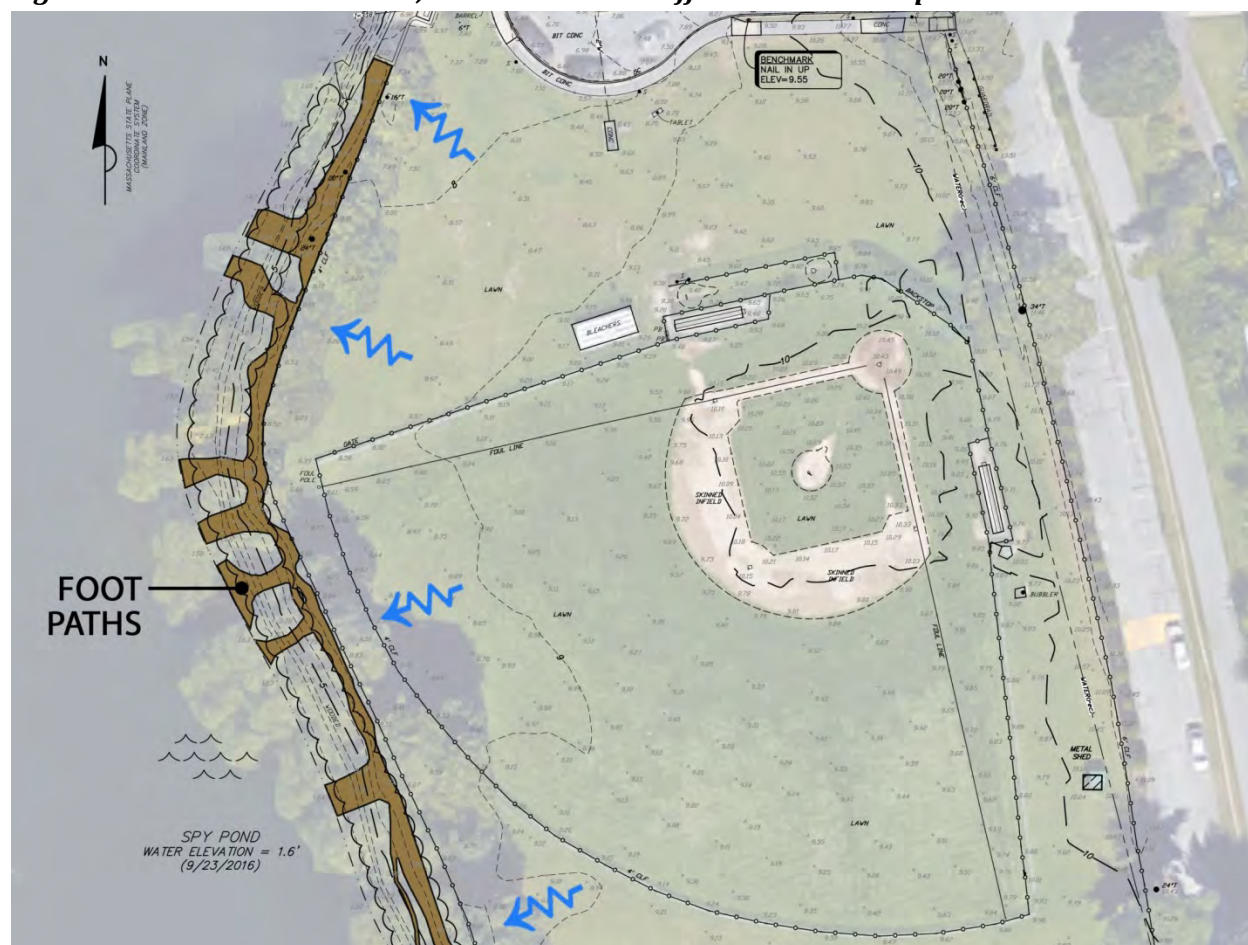
In addition to an actively eroding slope that contributes sediment to the pond, uninterrupted runoff from the athletic field, a likely source of nitrogen and phosphorous fertilization also affects the perennial decline of Spy Pond water quality.

Figure 3– Area1: Scannell Field, Uncontrolled Runoff & Erosion on Slope

As stated above, sheet flow across the athletic field is a likely source of contamination in the pond and, it also contributes to accelerated erosion on the slope. Mitigation is possible by constructing a linear swale along the fence line to stimulate infiltration. The swale could be linked to a bioretention basin in the open area near the cul-de-sac for more effective pollutant removal.

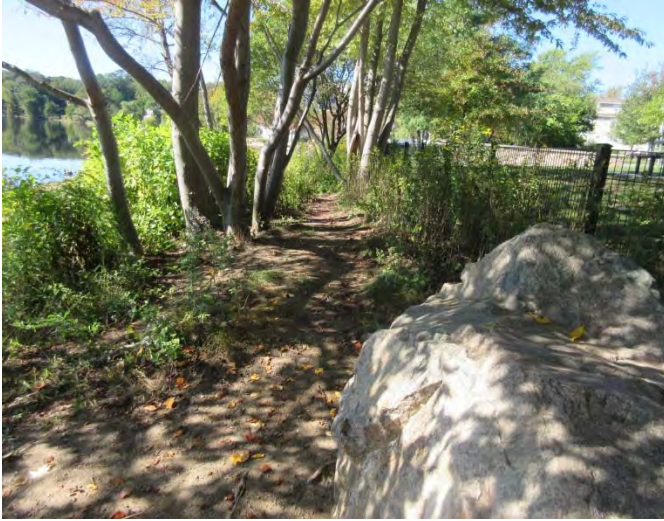
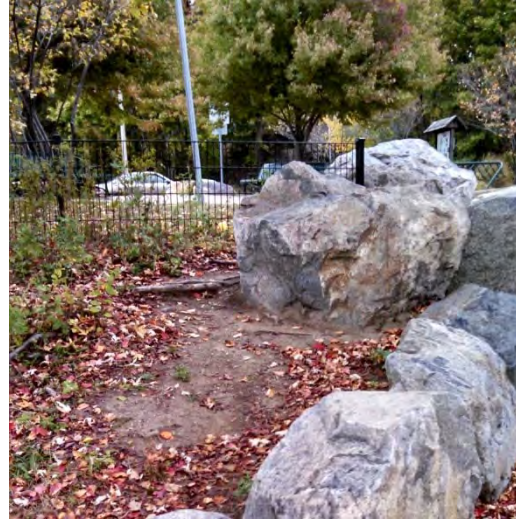
For the most part pedestrians limit themselves to the defined pathways; however, desire lines do exist along the slope to the pond in a few locations between the boat ramp and the beach providing additional access to the water. These informal pathways eliminate stabilizing vegetation that lead to erosion and, consequently, sedimentation in Spy Pond.

Photographs 5 and 6: Foot Paths in Plant Beds with Compacted Soil and Erosion

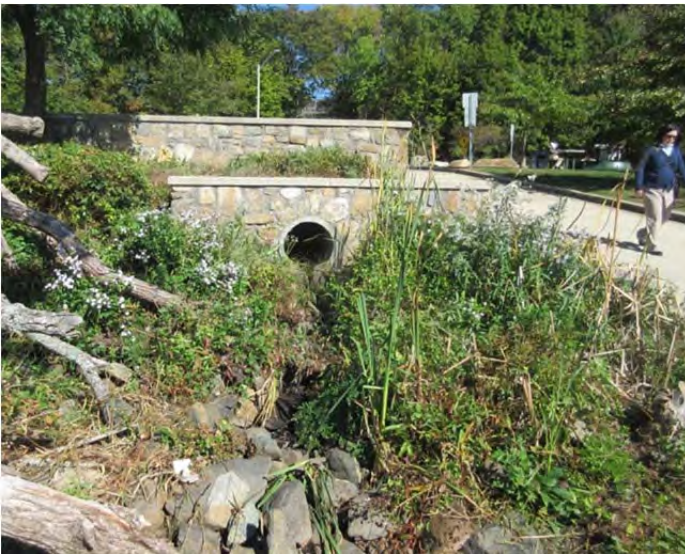
The area west of the boat ramp on the slope between the water and the retaining wall near the parking lot was not part of the renovations in 2006. This area is essentially removed from the center of activity in the park but it apparently attracts visitation as indicated by the casual pathways and loss of stabilizing vegetation. Dead and dying trees and a poorly maintained stormwater outfall indicate neglect for this somewhat isolated portion of the park.

Photograph 7: 18-inch Stormwater Outfall

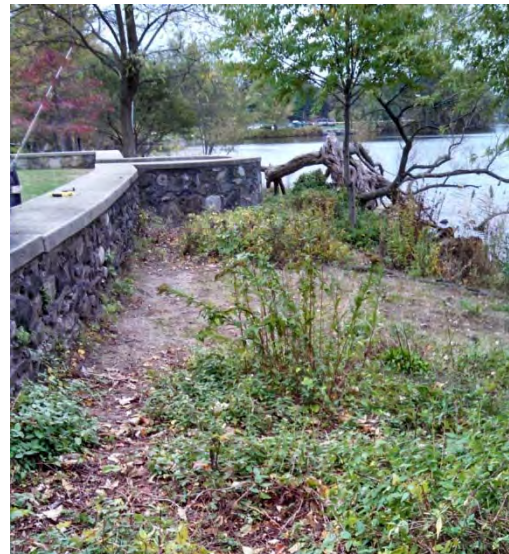
Photograph 8: Foot Path along Stone Wall

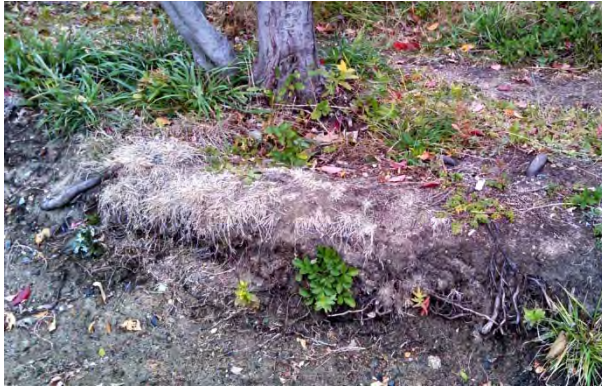
Photograph 9: Eroded Pond Edge

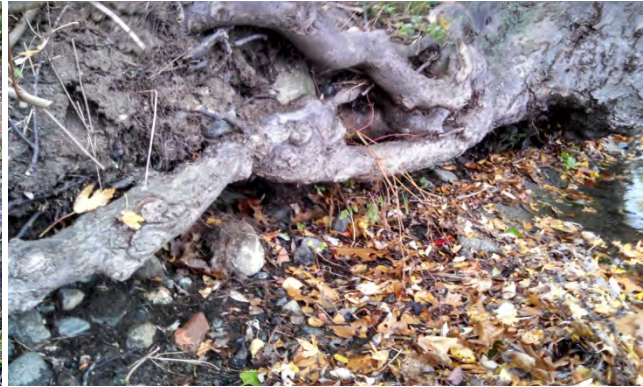
Photograph 10: Exposed Tree Roots Being Undercut

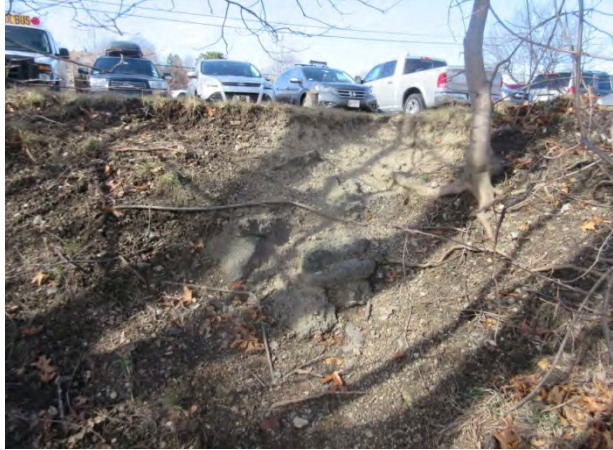
Photograph 11: Steep Eroded Slope

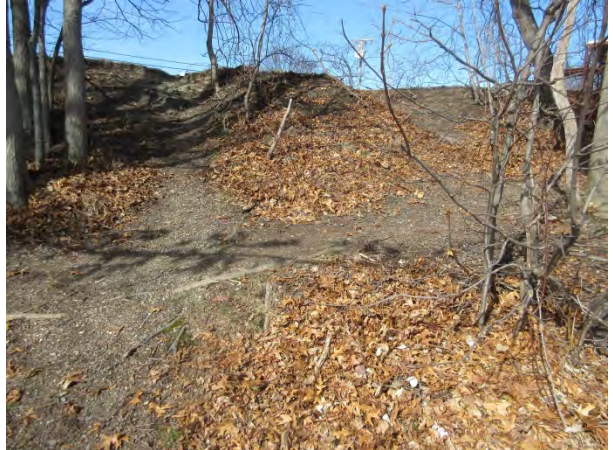
Vegetation in this location has not been disturbed to the extent that it has adjacent to Scannell Field since primary access is along the top of the slope in a grassed area. There are, however, nine separate pathways down the steep slope to another pathway at mid slope and, occasionally, along the water's edge. All nine have compacted, eroding soil that is deposited in the pond. As a relatively isolated area it

Photograph 12: Numerous Foot Paths

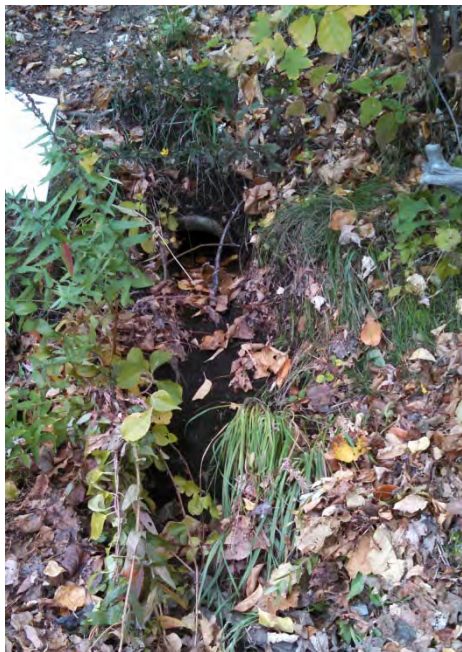
Stormwater from the adjacent pavement in Wellington Street and Pond Lane Extension drains into a catch basin at the curb next to this segment of parkland. From there it is piped through a manhole directly into Spy Pond at the base of the slope. The 12-inch outfall is partially filled with sediment and water. The outfall is ill-defined due to the lack of an endwall and the surrounding vegetation that grown in obscuring it from view.

Photograph 13: Obscured 12-inch Stormwater Outfall

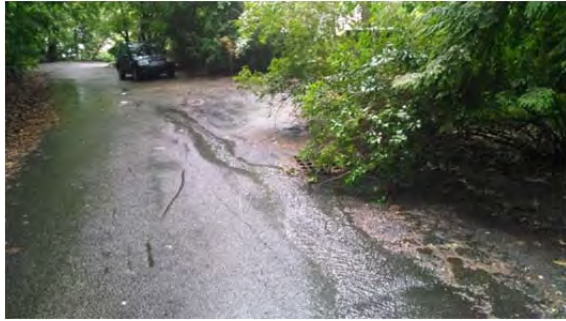
Photograph 14: Uncontrolled Stormwater Runoff

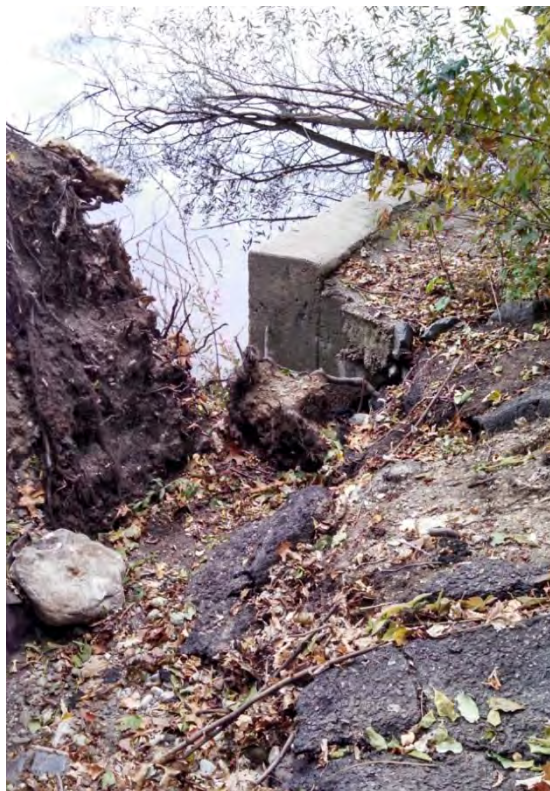
Photograph 16: Eroded Slope near Stormwater Outfall

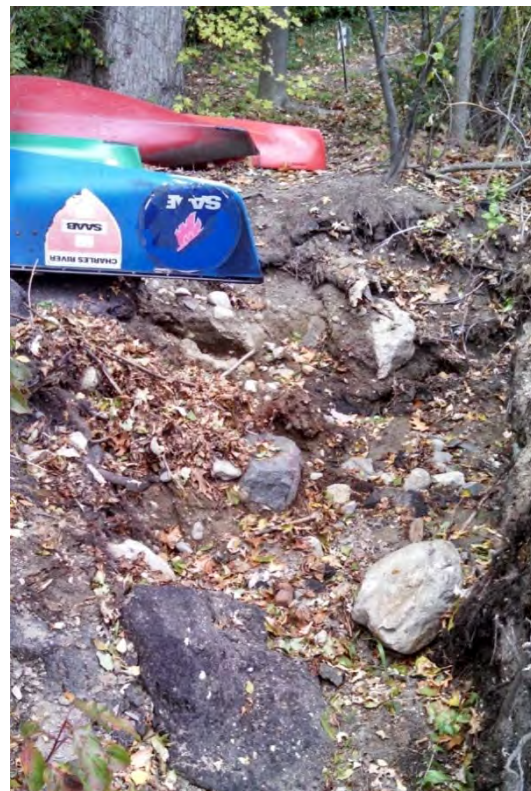
Photograph 17: Eroded Slope at the Uprooted Tree

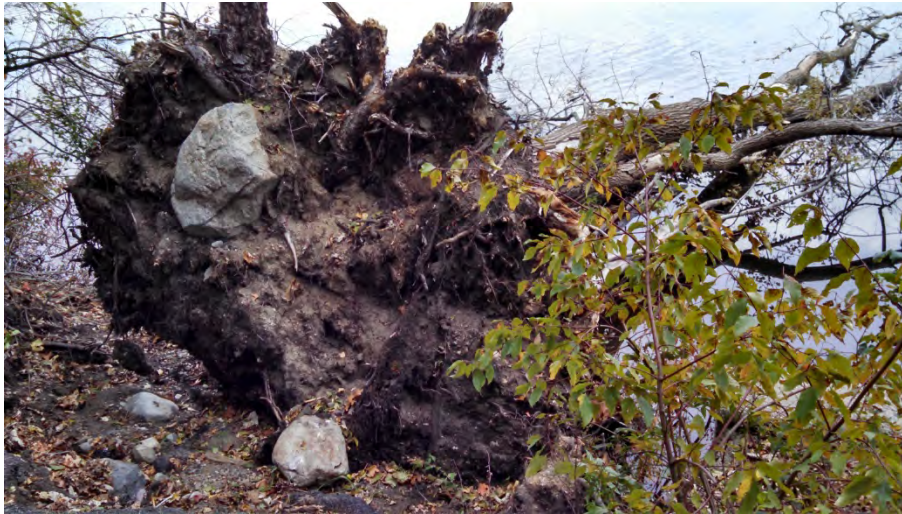
A recent rainfall event that produced high energy sheet flow across the paved boat launch area at the end Spring Valley Road undermined and overturned a 30-inch diameter poplar tree that served to stabilize the bank adjacent to Spy Pond. The upturned, root ball, approximately eight feet in diameter has created a large, eroding crater in the slope at the water's edge. The fallen tree extends out into the pond for approximately 80 feet, supported by broken limbs.

Photograph 18: Uprooted Tree
